# Structural properties of adobe dwellings in Cusco for seismic risk assessment

## ABSTRACT

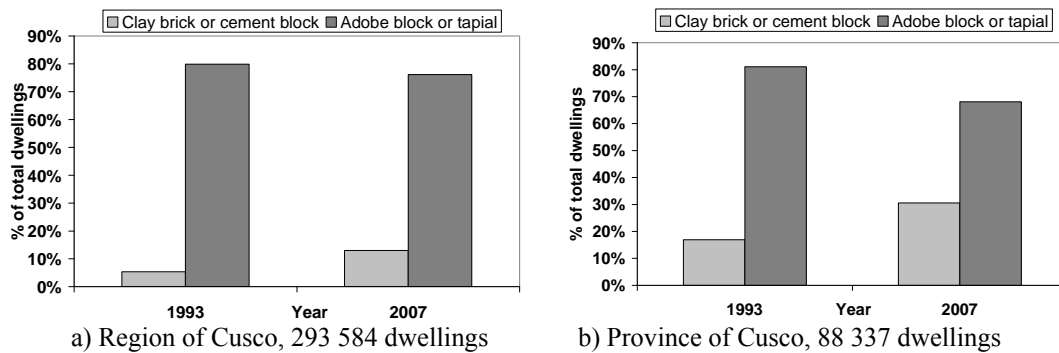
**Figure 1.** Percentage of adobe and clay brick masonry buildings in 1993 and 2007.

In Peru the total number of earthen dwellings (built in adobe or *tapial*) still forms an important percentage of the total number of Peruvian houses (INEI 2007). According to the last census, earthen buildings have decreased from 43% to 35% at of the a national level from 1993 to 2007. However, the region of Cusco (with more than 1,171,500 inhabitants and located at the Peruvian highland) maintains almost 76% of adobe houses (Figure 1a), though the percentage in the province of Cusco (which has more than 348,500 inhabitants) has decreased slightly from just over 80% in 1993 to around 68% in 2007 (Figure 1b). Despite this reduction, it is clear that in Cusco people build with adobe as a principal material.

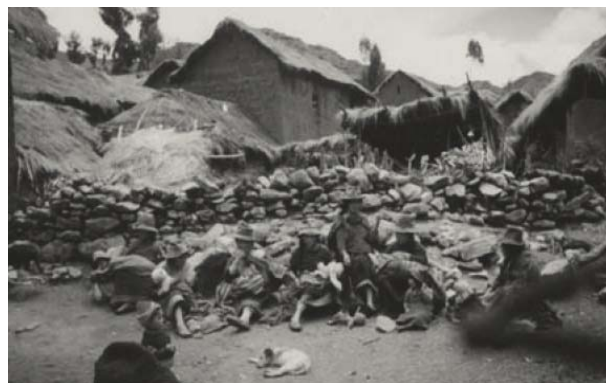
**Figure 2.** Rural adobe houses (Carazas 2001).

According to Carazas (2001), the construction in the rural area of Cusco (corresponding to the city periphery) has a strong pre-Hispanic influence, namely 1-storey adobe dwellings with two rooms, one of which is used for social activities, such as cooking or eating, and the other is generally used as a bedroom (Figure 2). There is no statistical data about the quantity of adobe houses of one or more storeys in Cusco. However, it can be concluded from Figure 3 that the majority of adobe houses has 1 or 2 rooms. Indirectly, it may thus be concluded that these houses, or at least the majority of them, will have only one level. Considering this assumption, in the region of Cusco almost 60% of adobe dwellings have 1 storey (see Figure 3a).

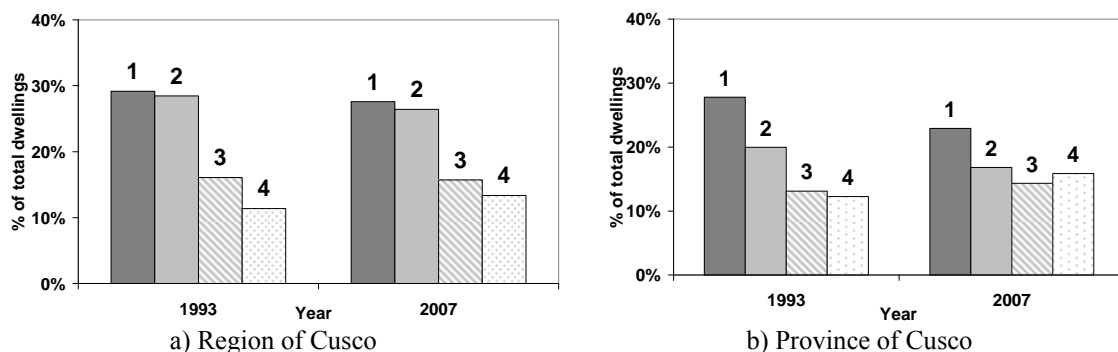
**Figure 3.** Number of rooms in adobe dwellings.

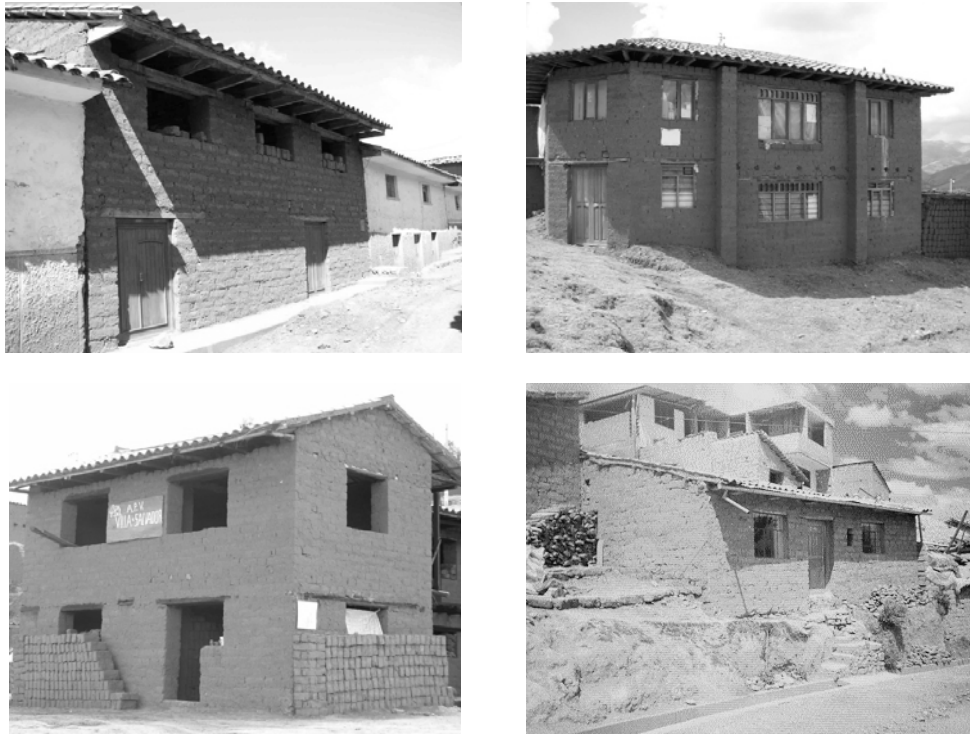
**Figure 4.** Rural adobe houses in Cusco (Blondet *et al.* 2004).

Considering the high concentration of adobe buildings in Cusco, as well as the moderate seismic hazard, this town has been selected by the Catholic University of Peru for a building-by-building survey to determine the structural characteristics of these buildings. Figure 4 shows some examples of

typical rural adobe houses in Cusco surveyed during a joint project between the Catholic University of Peru and SENCICO, a Governmental Institution.

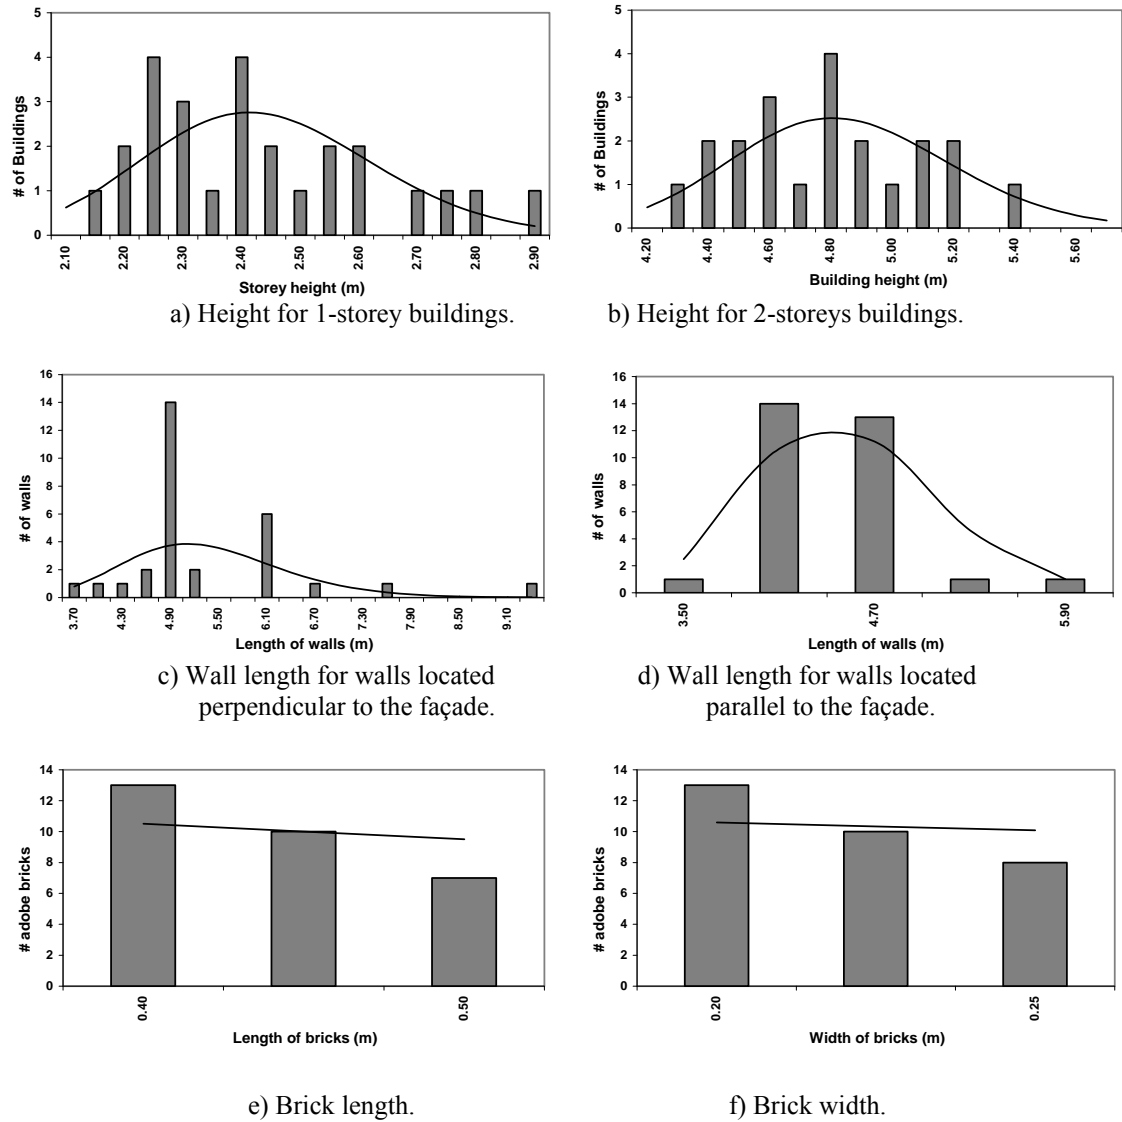
**Figure 5.** Histograms and PDFs of some geometrical properties.

The variability of each of the parameters in this study (i.e. walls length, adobe bricks dimensions, etc.) can be represented by histogram plots which can then be fit to a probability density function (PDF). Figure 5 shows the histograms and the best-fit PDF for some of the geometrical parameters presented previously.

From the 30 adobe dwellings, there were 25 buildings of two-storeys and 5 buildings of one-story. The building height of 4 of the two-storey buildings was missing; this meant that data from only 21 buildings was used to produce Figure 5b. To evaluate the mean and standard deviation values for the height of the walls of one storey-buildings, data from the 2 storey-buildings was added; this resulted in 26 values of height used to produce Figure 5a.

The normal or lognormal probability density distributions can represent fairly well the height of the buildings. The width of the windows and doors whilst the brick length and width probability distributions are fairly uniform. Neither the normal nor the lognormal distribution fit well the length of the walls in the direction perpendicular to the façade (Figure 5c), or the length of the walls placed parallel to the façade (Figure 5d). However, it is noted that a different histogram may be obtained if the data are grouped considering different interval sizes.

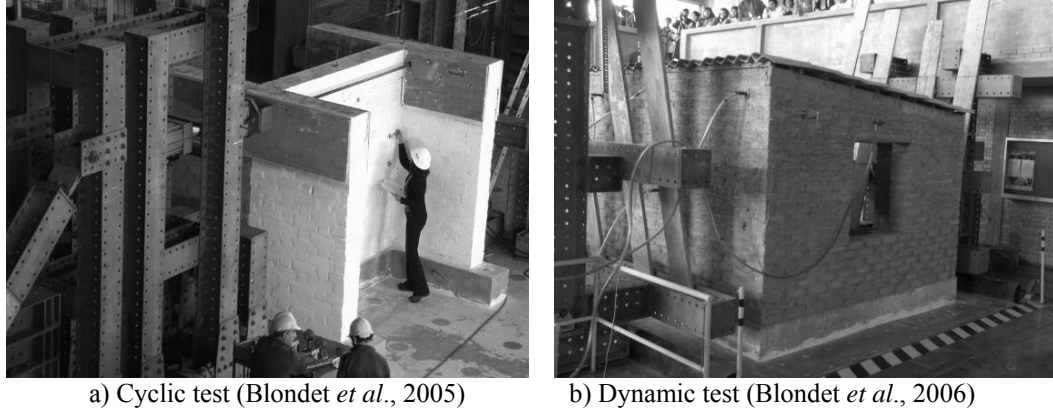
**Figure 6.** Tests carried out at the Catholic University of Peru.

The material and dynamic properties are based on tests carried out at the Catholic University of Peru (PUCP). In 2005, a displacement controlled cyclic test (push and pull test) was carried out on an adobe wall by Blondet *et al.* (2005, Figure 6a). In 2006, a dynamic test was performed over the unidirectional shaking table of the PUCP on a full-scale adobe module (Blondet *et al.* 2006, see Figure 6b).

Based on the cyclic test performed on the wall specimen shown in Figure 6a, four limit states of damage have been obtained based on the grade of damage (Figure 7b). Until 0.05% drift, the structure can be considered as elastic (LS1), which means fully operational. After that level of drift, the structure can have some cracks but is still functional (LS2), until 0.1% of drift. Then, the life-safety performance (LS3) is reached at 0.26% of drift and, finally, the structure is considered near to collapse at 0.52% of drift (Tarque 2008). The last limit state does not necessarily means collapse of the structure; it can be specified that the cracks are not particularly serious unless the relative displacement across them becomes large, which means the overturning of the small blocks of walls formed by the cracks (Webster 2008).

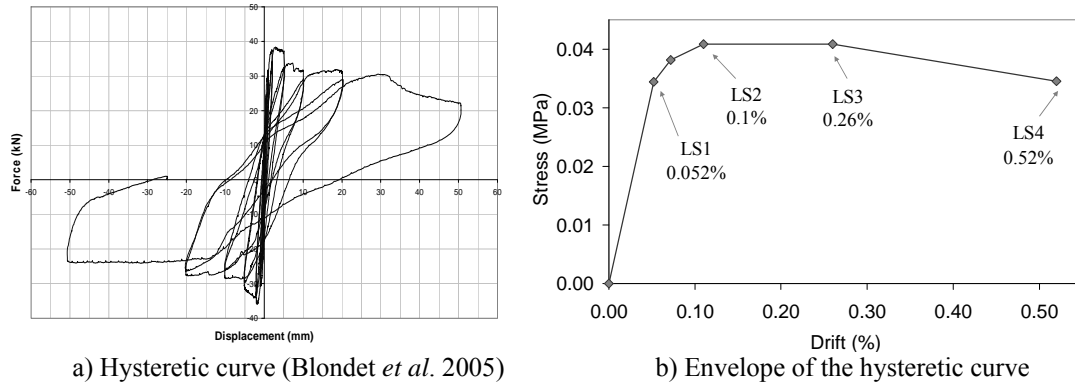
**Figure 7.** Capacity curve derived for the test results on adobe wall subjected to in-plane forces.

The elastic stiffness  $K$  was obtained from the capacity curve (Figure 7) and with this parameter it was possible to calculate the elasticity modulus  $E$  based on Equation 3.1 (cantilever beam subjected to flexural and shear deformations).

where  $H$  represents the wall height,  $I$  the moment of inertia of the section,  $A_v$  the shear area and  $G$  the shear modulus, which was taken as  $0.4E$ . The Young modulus was found to be around 135 MPa. With the weight of the wall (135 kN) and with the elastic stiffness it was calculated the elastic period of vibration with the expression  $T = 2\pi(M/K)^{0.5}$ . The period estimated for the wall is  $T_y = 0.15$  s. From the dynamic test (Figure 6b), a period of vibration of around 0.16 s was obtained directly from a free vibration test carried out previously to the beginning of the dynamic test.

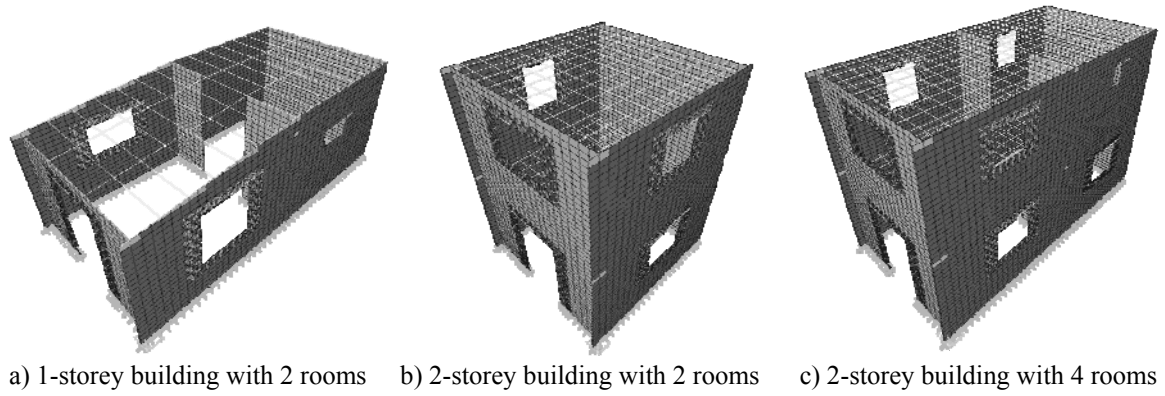
**Figure 8.** Analytical model for adobe buildings.

The periods of vibration obtained from the experimental test results were compared with the results of preliminary elastic numerical analyses performed with commercial finite element software for different configurations of adobe buildings (see Figure 8). A reduced Young modulus,  $0.6E$ , was used for the computation of elastic vibration periods, considering that at the first limit state the adobe walls were already cracked (Tarque 2008). Analytical models with different heights and with different configurations were developed to study the influence of these parameters in the variation of the vibration period. The vibration periods obtained with the experimental tests and with the analytical models are plotted in Figure 9, as function of the building height.

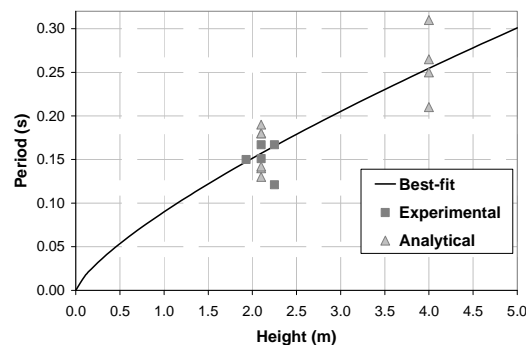
**Figure 9.** Vibration period versus building height (experimental and analytical data and best-fit regression curve).

To make a correlation between the period of vibration and the height of the walls ( $H$ ), the following formulation was applied:  $T = \alpha H^\beta$ . From a best-fit regression analysis the values of  $\alpha$  and  $\beta$  results in  $T_y = 0.09H^{3/4}$ . The values of vibration period given by the correlation founded are higher than the formula proposed in many codes around the world for masonry buildings (which is often taken as  $T = 0.05H^{3/4}$ ), because this formula was obtained from the measured vibration periods of load-bearing wall buildings at low levels of ground shaking and has been calibrated to underestimate the period by 10-20% so that higher forces will be predicted from the design acceleration spectrum, which is inversely proportionally to period (Goel and Chopra 1998). It is important to remark that the period of vibration which has been derived in the current study correspond to a cracked period of vibration which is to be used for assessment, and thus a realistic prediction of the expected period of vibration is required.
